# PAS 24:2016

**Test of: Inward-Opening Single Timber Doorset**

**Enhanced security performance requirements for doorsets**

WIL 414072

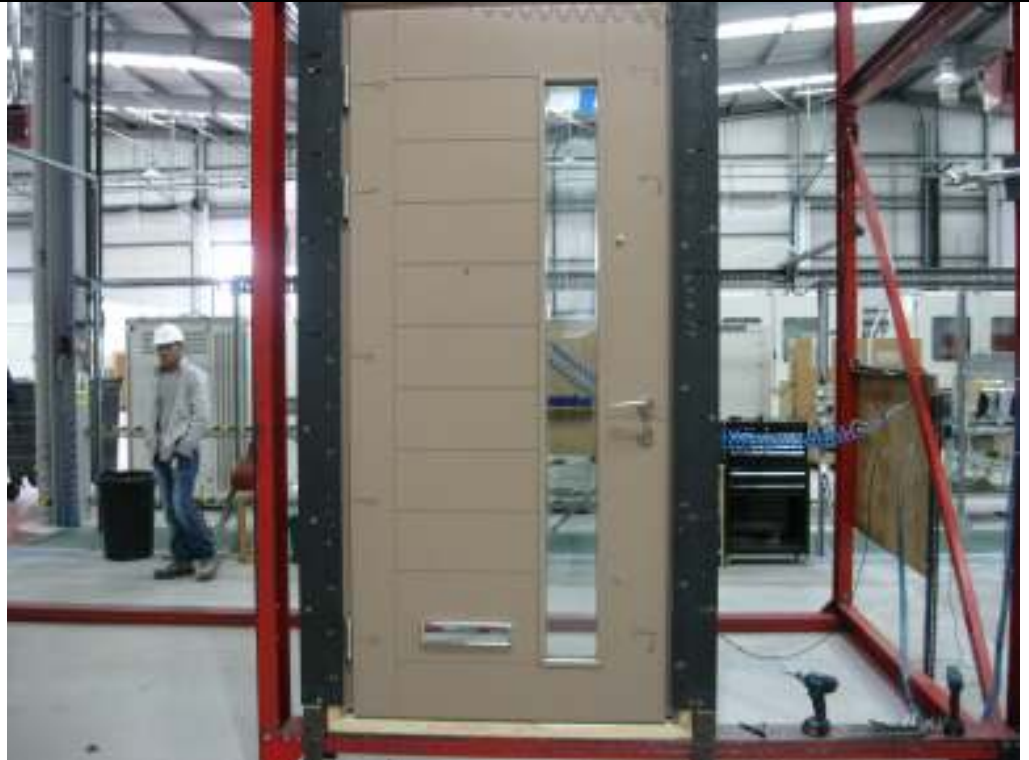
**The internal face  
of the sample**

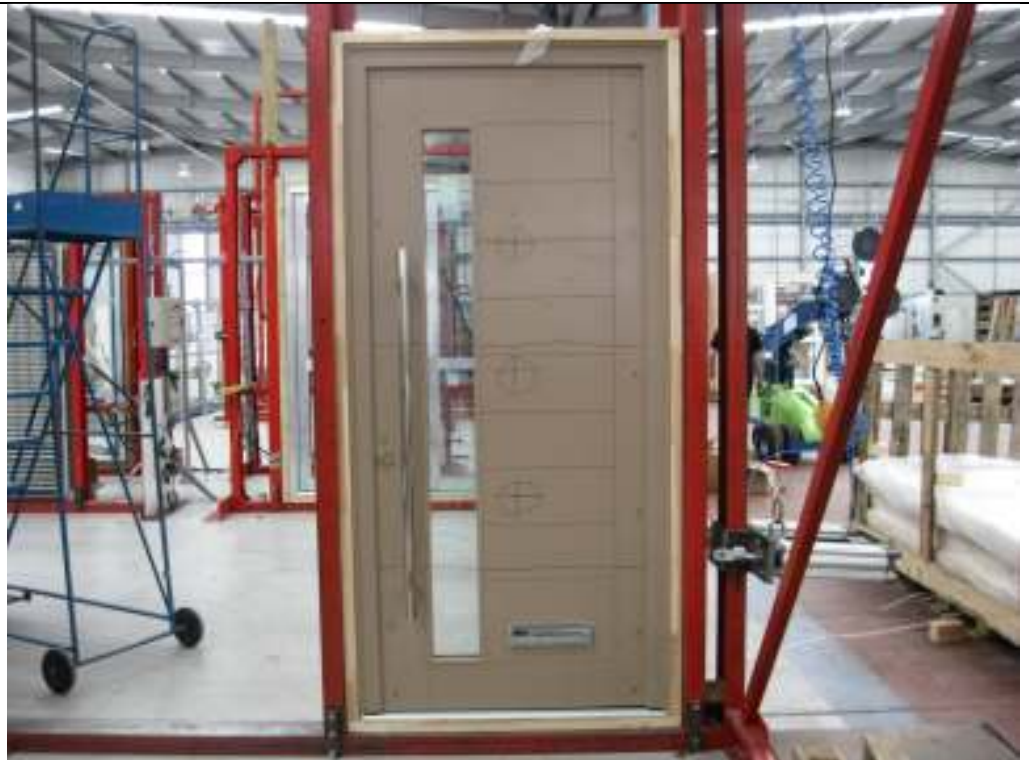
**The external face  
of the sample**

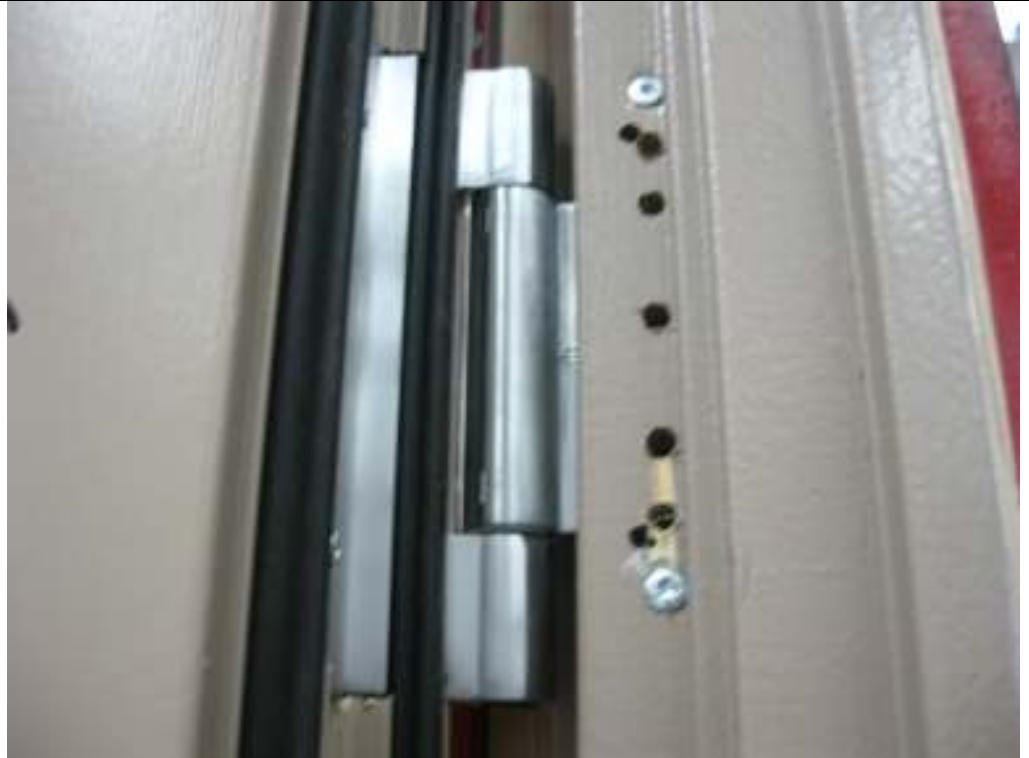
**Sample hinge**

Supplier	:	<b>Simonswerk</b>
Description	:	BAKA 3D Hinge
Reference	:	4030 3D FD
Primary material	:	Steel
Quantity	:	3
Size of knuckle	:	20 mm (Diameter)
Size of blades	:	3,5x39x140mm
Fixing hinge to doorleaf		
iv. type	:	Wood screws into doorleaf
v. size	:	5 x 40 mm
vi. quantity	:	5No
Fixing hinge to frame		
i. type	:	Pins
ii. size	:	M6x45 bolt
iii. quantity	:	2No
Position of hinge		
i. top hinge	:	2109 mm from bottom of door to center of hinge
ii. middle hinge	:	1739 mm from bottom of door to center of hinge
iii. bottom hinge	:	255 mm from bottom of door to center of hinge

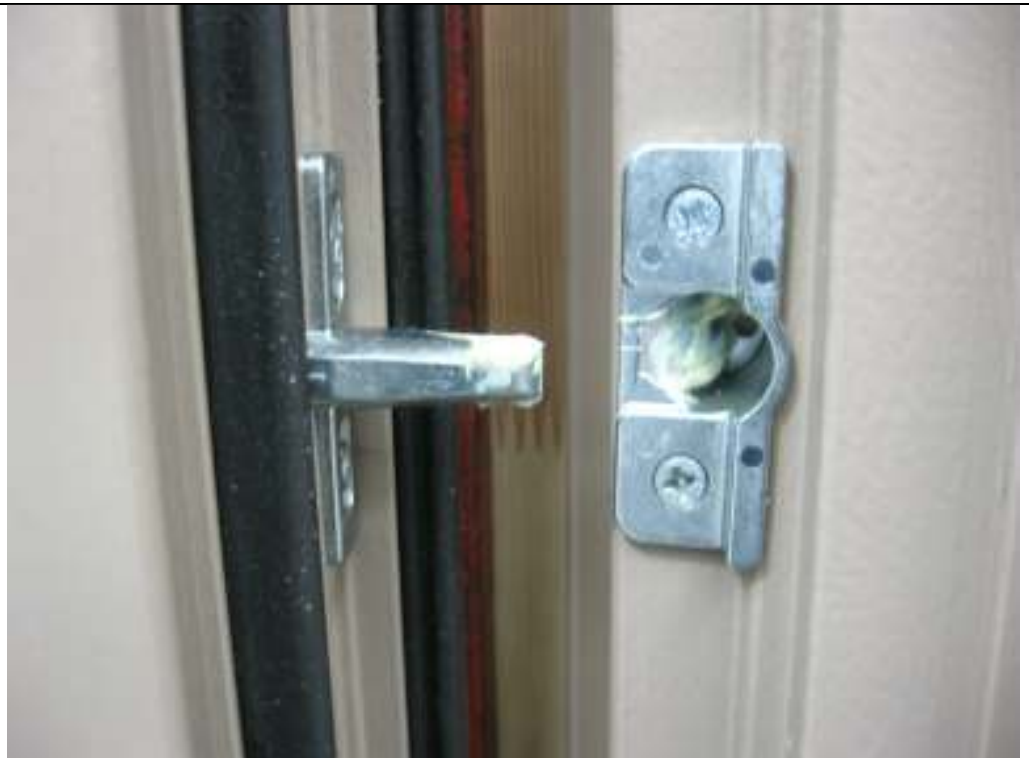
**Sample dog bolt**

Supplier	:	<b>MACO</b>
Description	:	Dog bolts ( Lock & Lock Keeps)
Reference	:	97528 & 94089
Material	:	Steel
Quantity & position	:	2No & 2No
Overall size		
i. dog bolt	:	58x42x21 mm
ii. retaining ring / keeper	:	58x32x24 mm

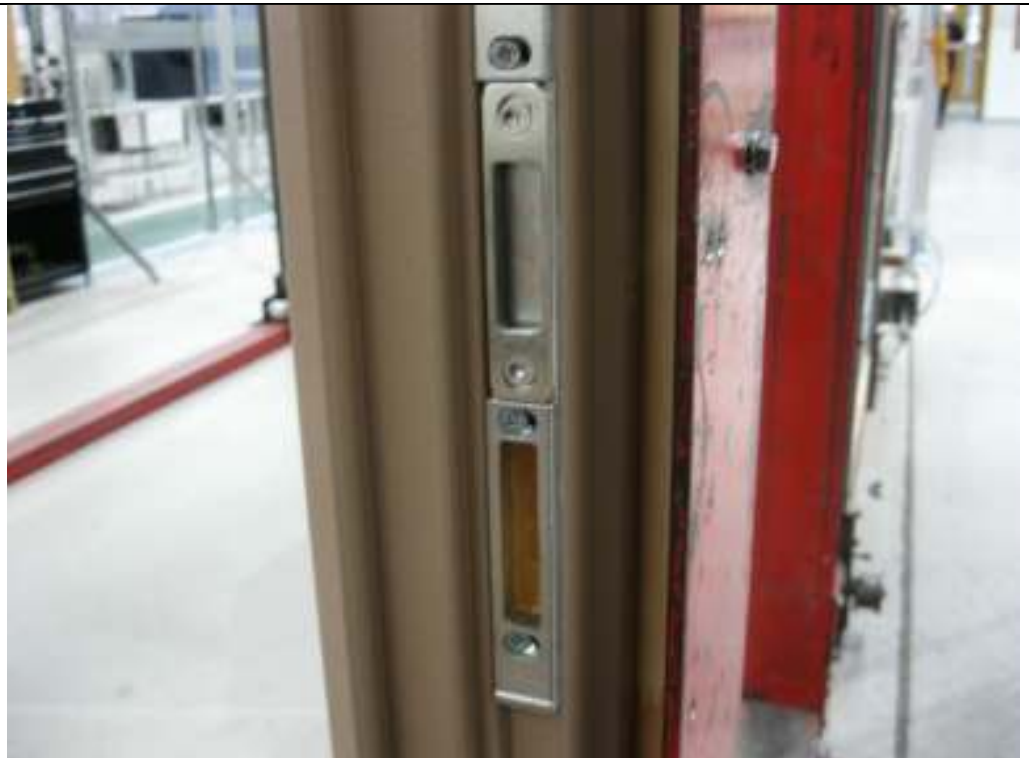
### Sample lock keep

Supplier	:	Maco
Description	:	Striker plates
Reference	:	1No (29787) 3No ( 29980)
Material		
i. top & bottom keeps	:	29980
ii. centre keep	:	29787
Overall size		Metal in
i. top & bottom keeps	:	8x20x120 mm
ii. centre keep	:	8x20x208 mm
Fixing keeps to frame		
i. type	:	Screws
ii. size	:	4 x 30 mm
iii. quantity	:	2

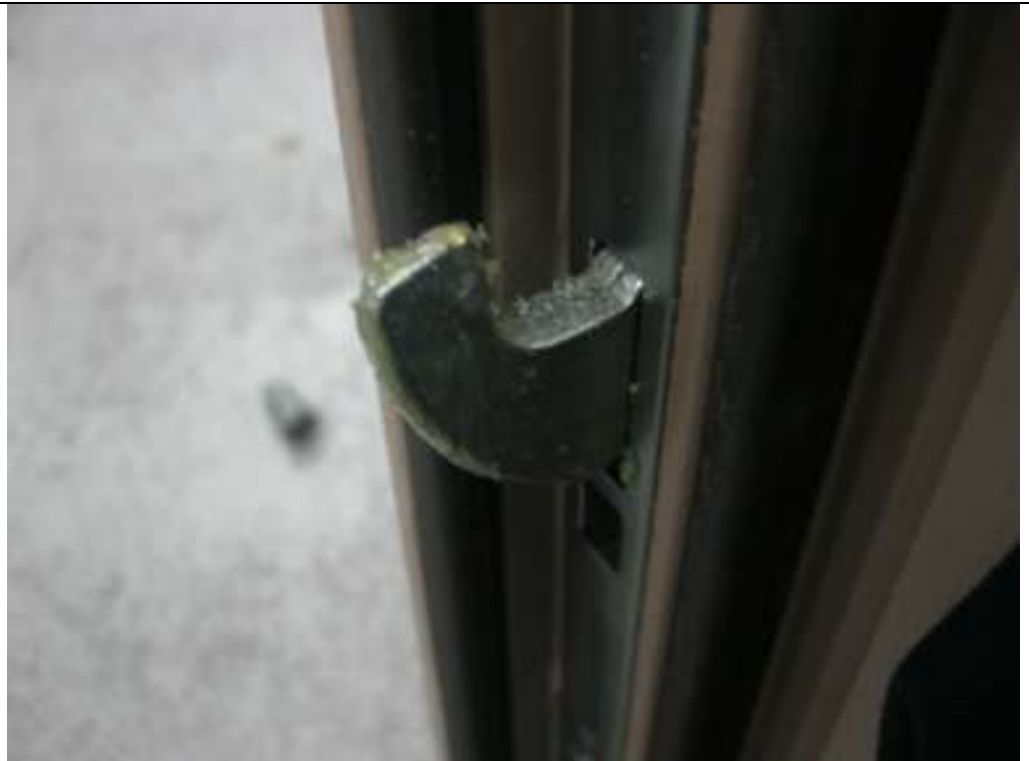
**Sample bottom  
hook bolt**

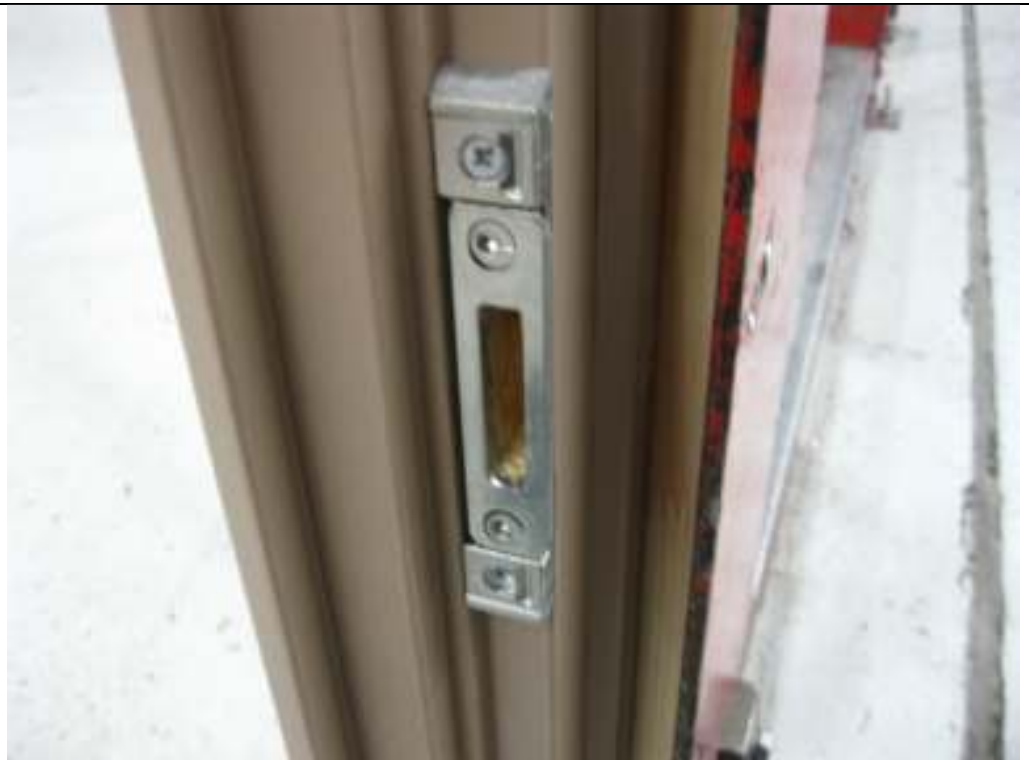
**Sample bottom  
hook bolt keep**
